THE USE OF TABLETPCS AND GEOSPATIAL TECHNOLOGIES FOR PAVEMENT  
EVALUATION AND MANAGEMENT AT DENVER INTERNATIONAL AIRPORT

PRESENTED FOR THE  
2007 FAA WORLDWIDE AIRPORT TECHNOLOGY TRANSFER CONFERENCE  
Atlantic City, New Jersey, USA

April 2007

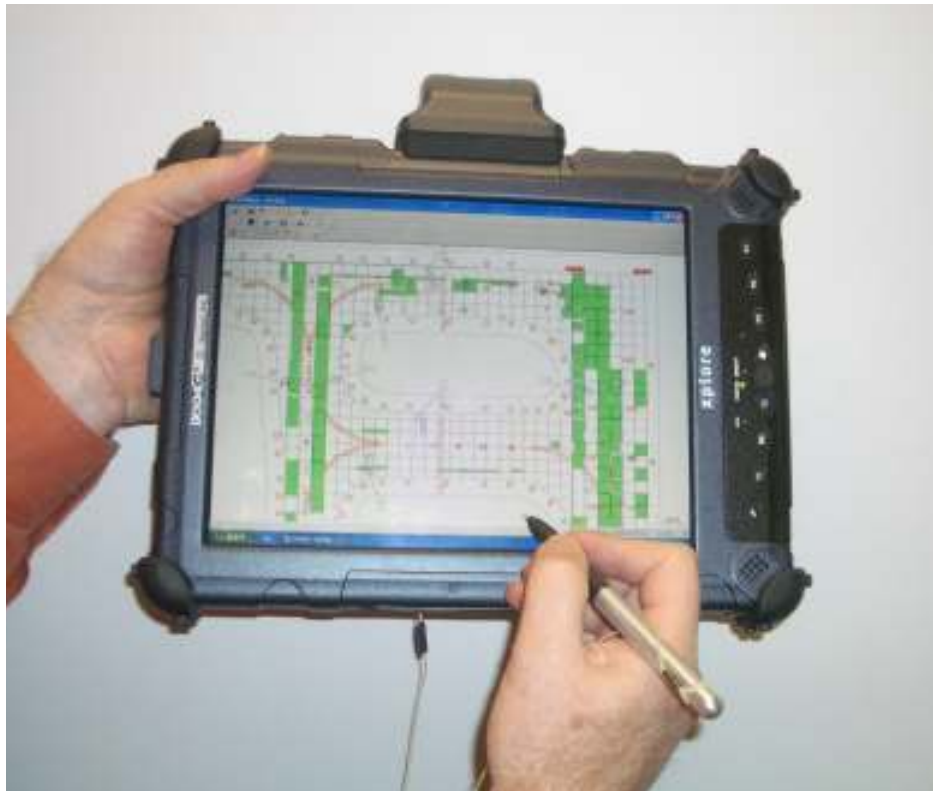
The DEN project selected a ruggedized tabletPC shown in Figure 1 that is marketed for constant field use and has a sunlight readable screen. The specific model was chosen because it could be fitted with an integrated Wide Area Augmentation System (WAAS) capable GPS that attaches directly to and communicates directly with the tabletPC. Other models of tabletPCs that were less rugged and used Bluetooth for GPS communication were considered as they had been used successfully on other airport pavement evaluations. However, because of the large amount of pavement to rate and time frame in which to rate the pavements, the ruggedized tabletPCs were considered wise investments in productivity.

Figure 1. Ruggedized TabletPC and integrated GPS used at DEN.

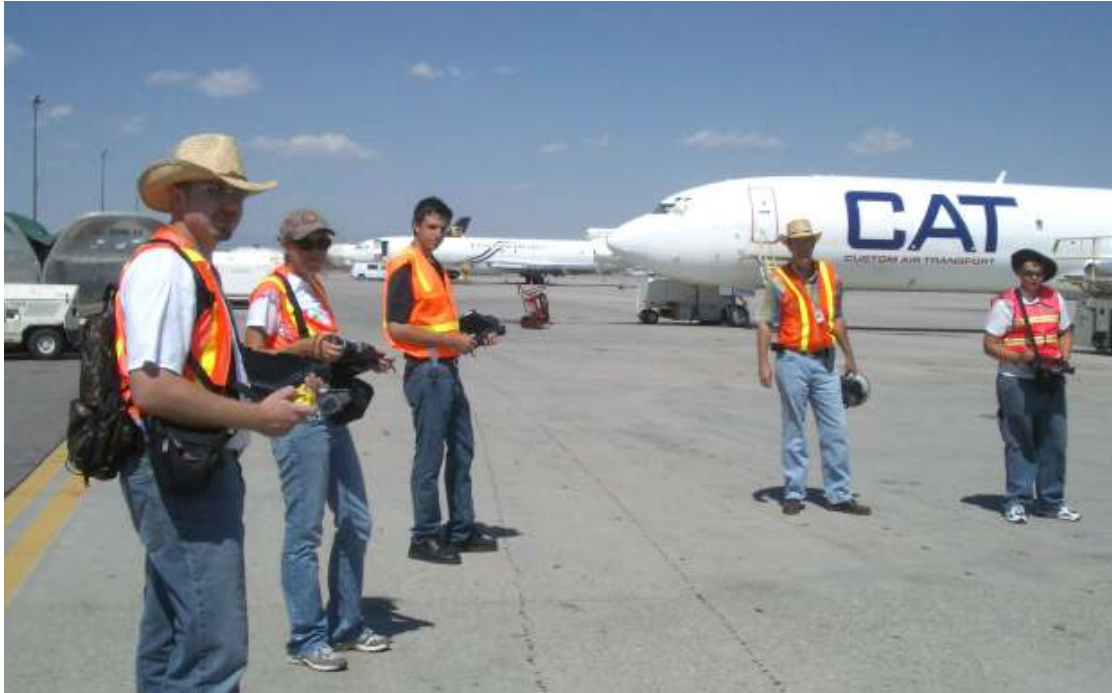
The compressed time schedule, the short runway closure time windows, and the requirement to always be flexible resulted in selecting a potential crew rating size of up to 8 raters at a given time. DEN has six runways; one constructed in 2003 is 16,000 feet long and 200 feet wide. The original five runways that were constructed in 1992 and 1993 are 12,000 feet long and 150 feet wide. Four runways are eight slabs of 18.75 feet in width and one runway is 6 slabs of 25 feet in width. A survey crew of 8 could walk along a runway with one rater per slab lane observing 100% of the distresses. Therefore, eight tabletPCs and eight GPS capable camera were acquired for this project. However, on any given day a typical pavement crew as shown in Figure 2 consisted of 3 to 6 raters.

Figure 2. A Typical Daily Pavement Rating Crew at DEN.

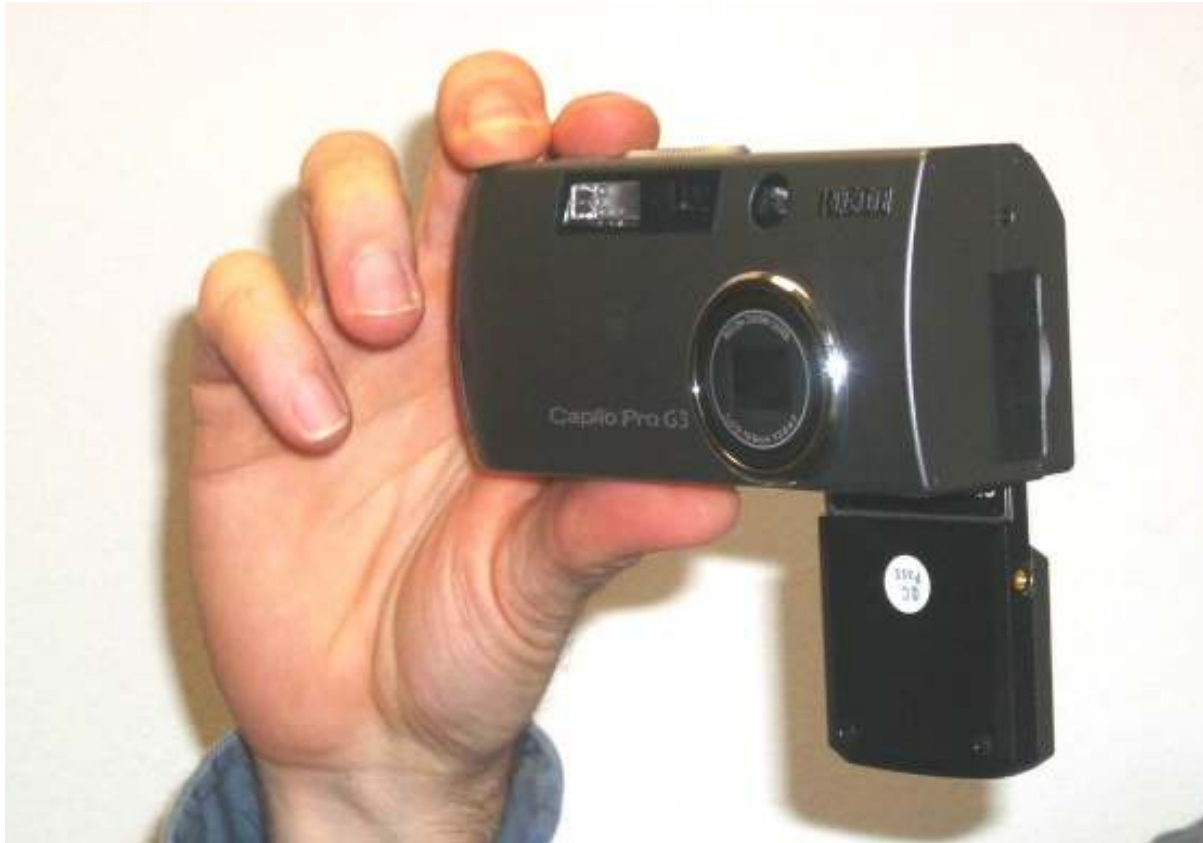
digital cameras as shown in Figure 3 with a WAAS compatible GPS in a compact flashcard. The instructions were not that every slab or every distress was worthy of photographs, but a photo should be taken of anything different or unusual. Photography was also requested of areas of map cracking as it was a areas of special emphasis..

Figure 3. Digital Camera with GPS attached.
